Manhole Inspection Summary

Manhole # S3500_037MH

Location Address: **300 23RD ST**

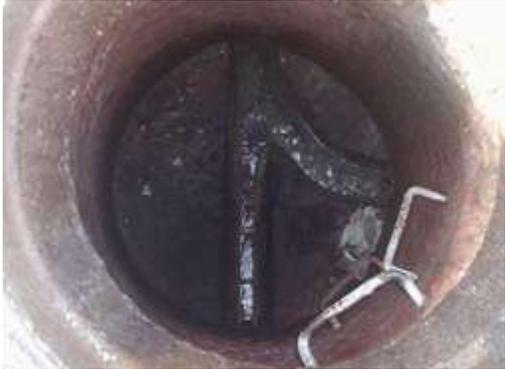
Top View

Corroded steps. Evidence of surcharge - Bench debris. Channel debris (grease).

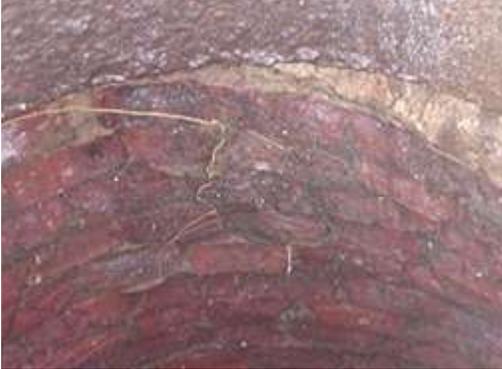
Defect

Frame leaks. Adjustment deterioration, root intrusion and infiltration.

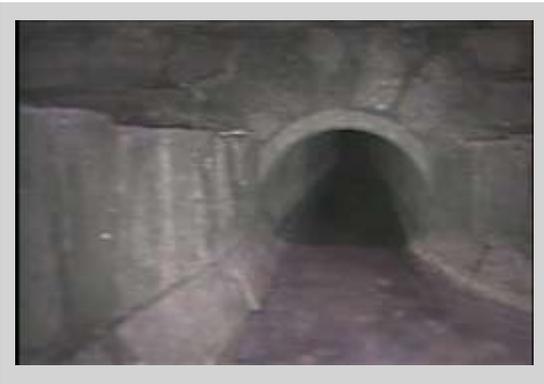
8 in. Circular Gravity Sewer Pipe Out @ 12 O'Clock

Deposits: None **Mud** Sludge **Debris** Grease

Silt Depth: **0** (in.) Deposits Extent: **Light**

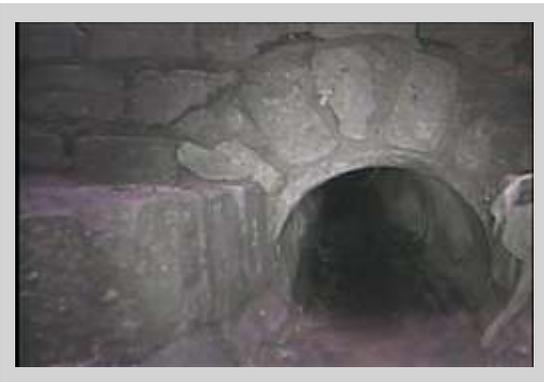
8 in. Circular Gravity Sewer Pipe In @ 3 O'Clock

Barrel deterioration and infiltration.

Deposits: None **Mud** Sludge **Debris** Grease

Silt Depth: **0** (in.) Deposits Extent: **Light**
